Belvidere Historic Resources Inventory: Commercial Historic District

Section B

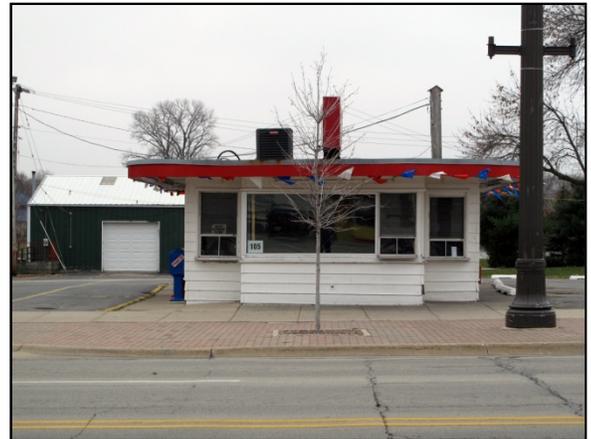
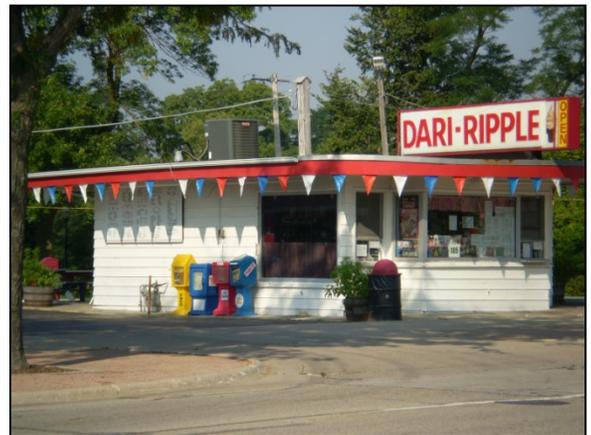
Photo ID: 050_1

Class: Building Condition: Good Integrity: High

Wooden frame structure sheathed in clapboards designed to serve as an ice cream sales building. A contemporary corrugated metal pole barn is sited behind and south of the structure on the same parcel. A roof-top lighted sign, probably dating from the building's original construction, has been retained.

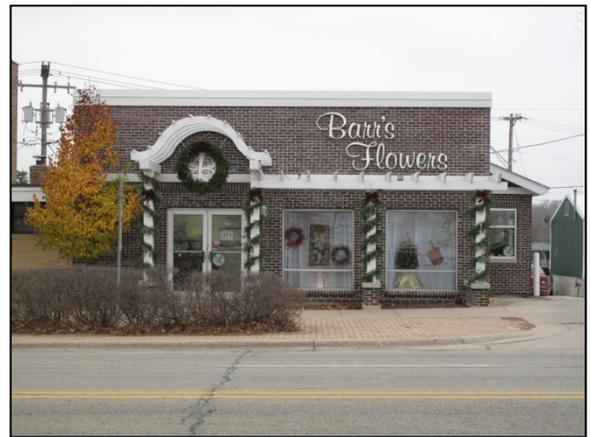
Photo ID: 052

Class: Building Condition: Good Integrity: Low

This single-story masonry building has a recently-constructed façade of gray brick. The main façade presents three bays, the first presenting a double door entry in contemporary metal and glass. The two bays to the right each present a large plate glass window. A pergola supported by wooden posts on brick plinths leads from the parking lot past the shop windows to the main entrance. Above the pergola is the name of the business, and a simple cornice tops the parapet wall. A small dependency with a shed roof projects from the north side of the building.

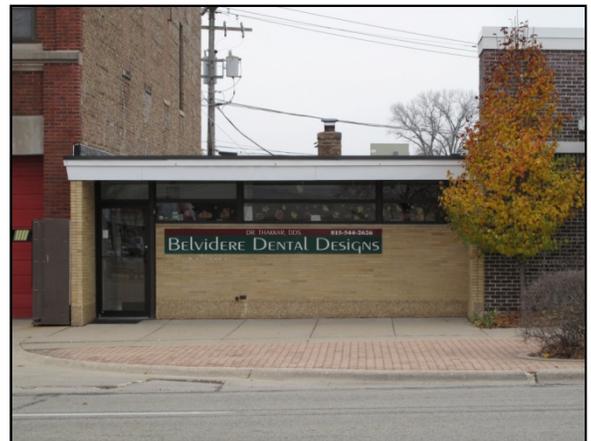
Photo ID: 053

Class: Building Condition: Good Integrity: Medium

A one-story yellow brick structure maintains its original lines inspired by the International-Style. The metal and glass of the entry on the left is visually connected to the narrow ribbon of glass and metal, supported by a thin limestone sill, that extends across the façade. Although the windows have been replaced and the soffit has been covered in wood, the original lines of the building are intact, making it a good example of the style.

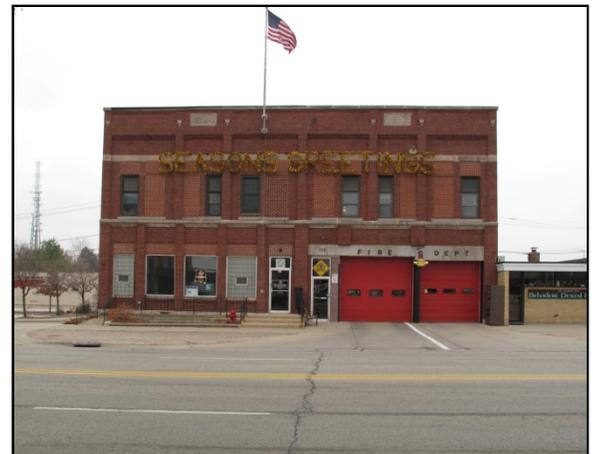
Photo ID: 054

Class: Building Condition: Good Integrity: Medium

This façade of this two-story building of red brick building is divided cleanly in two. On the left, five bays on the first floor are marked by heavy brick pilasters which appear to support a simple projecting cornice of stone. The penetrations in the first floor bays have been partially filled with glass block and masonry except for the far right bay, which presents a metal and glass entry. The second floor presents three bays. The central bay is the same width as the one below it and presents a pair of narrow window penetrations, the one on the left filled with masonry. The central bay is flanked by two wider bays presenting two window penetrations each. Replacement windows shorter than the originals have been installed in two of these openings, and the others have been filled with masonry. Above the central bay is a cast stone plaque noting this portion of the building's construction date, 1884.

The right half of the building is of the same size and massing, except that the first floor bays have been reduced in number to three. The far left bay includes a contemporary metal and glass entrance, and the other two bays, of varying size, each present an overhead door providing access to the Fire Department's apparatus bays. The arrangement and treatment of window bays and penetrations on this side of the building are identical to those on the left; a cast stone plaque noting the construction date of the building addition, 1917, is centered above this section of the building.

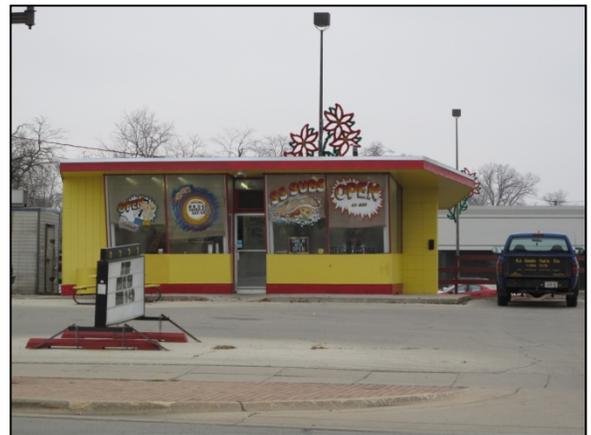
Photo ID: 055

Class: Building Condition: Good Integrity: Medium

A small, single story structure of concrete masonry units was probably constructed as a service station. A centrally-located door is recessed between plate glass windows which angle outward as they rise. These angles are repeated by the cant of the roof, which is higher in front of the building than behind.

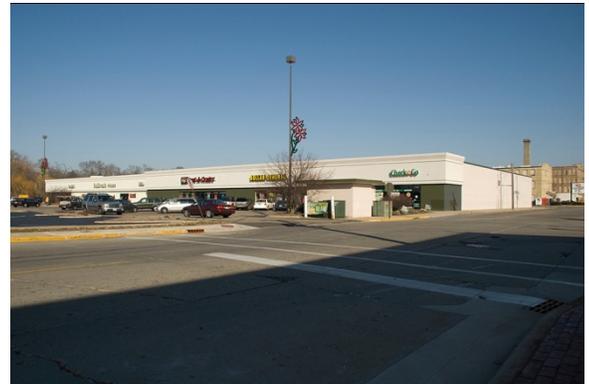
Photo ID: 056

A contemporary shopping plaza of concrete masonry units with a stucco-like coating. A simple cornice in a contrasting material stretches across the main façade. The property includes a small utility structure near Whitney Boulevard.

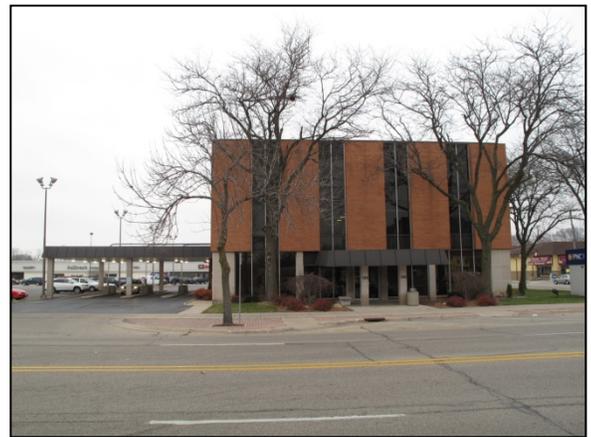
Photo ID: 057

This mid-century bank presents elements of the International Style. Both strong horizontal and vertical orientations are present. The horizontal features are clear in the broad flat roof over the drive-through lanes which is repeated in the canopy over the main entrance and the use of concrete and glass across the first floor façade, which contrasts sharply with the brick on the upper floors. Those upper floors present the vertical orientation, with bands of dark glass windows rising from the first floor to the roof with panels of red brick between.

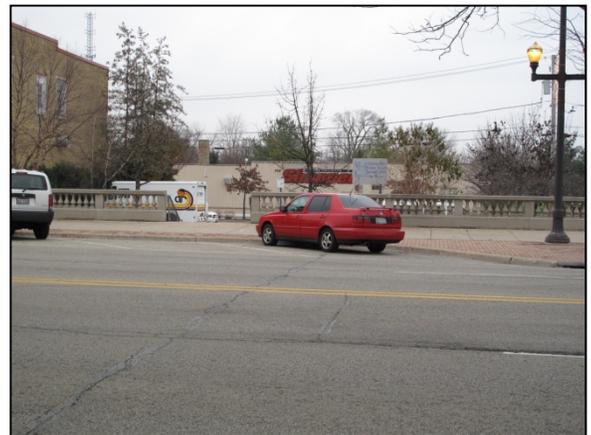
Photo ID: 058

A sunken parking lot with landscaping and a concrete railing matching the State Street Bridge spans this city-owned lot.

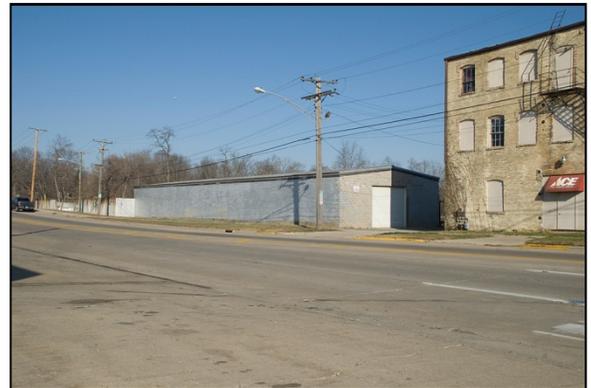
Photo ID: 140

A simple rectangular building of concrete masonry units with what appears to be a shallow gable roof of corrugated metal. A vehicular overhead door is centered in the south façade.

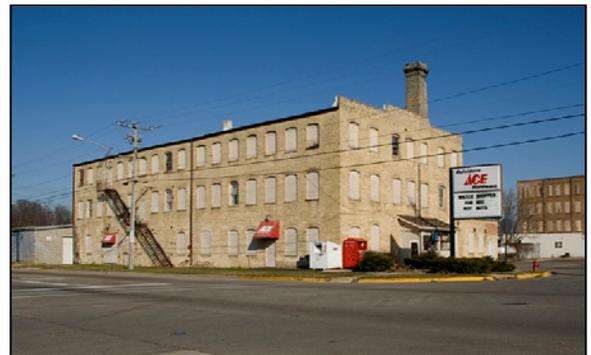
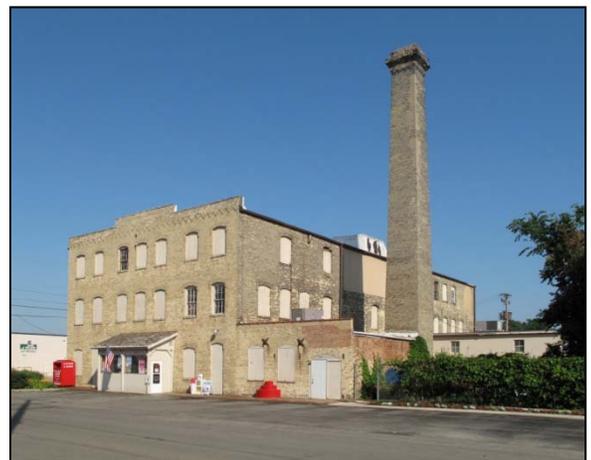
Photo ID: 141_1

This three-story building was constructed of wood with brick veneer as a shoe factory. The main façade presents seven bays, with a group of three centered in the façade. On the first floor, the central three bays are taken up by a covered entry constructed of contemporary materials. On either side, a pair of penetrations once served as windows or doors. They are now boarded up. The second and third floors each present seven window penetrations, three grouped in the center planked by a pair. All but three of these have been boarded up. The three windows are six-over-six double-hung windows. All of the penetrations retain their brick window hoods, which accentuate the segmental arches at the top of each penetration. A cornice of corbelled brick supports a plain parapet wall which rises higher above the center three windows and is capped with plain stone coping.

The east and west facades of the building present similar window penetrations regularly spaced across each façade. The north façade differs, as the upper floors have fewer penetrations, and presents some vertical metal sheathing on the third floor. The east façade also presents a one-story dependency built to house the building's power plant. A wide opening has been filled with a single steel door with wooden fill, and a smokestack towers above the rear of this section of the building.

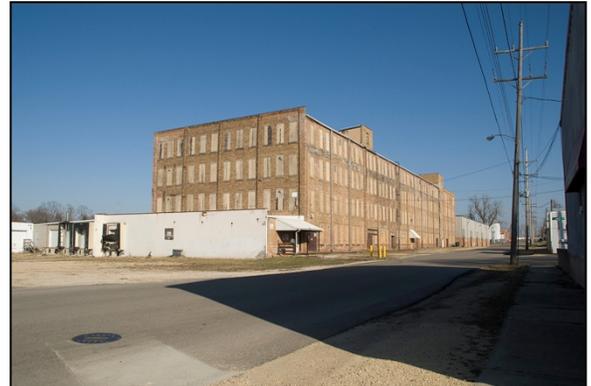
Photo ID: 142

The 1901 structure presents a rubble foundation that supports the masonry walls and twelve rows of six wooden posts supporting each floor of the building and the roof. These posts support a series of beams that extend along the length of the building, which in turn support the joists for each floor, which extend across the width of the building. In addition to maintaining what appears to be the original hardwood flooring, the building includes the original wooden staircase and many of the original double-hung windows. Interior photos of other buildings in the factory complex show identical construction materials and methods for buildings constructed between 1896 and 1900.

The 1927 section of the building is similar in construction, with the exception that the posts and floors are of concrete rather than wood. Marks from the wooden molds used to create the building's concrete frame are clearly visible, exemplifying the construction technique. This section of the building is separated from the older section by heavy fire doors dating to the addition's original construction.

During the 1970s, a steel-frame addition with walls of brick, concrete masonry units, and corrugated metal measuring approximately 150 x 200 feet was constructed on the east side of the building.
