Belvidere Historic Resources Inventory: Commercial Historic District

Section A

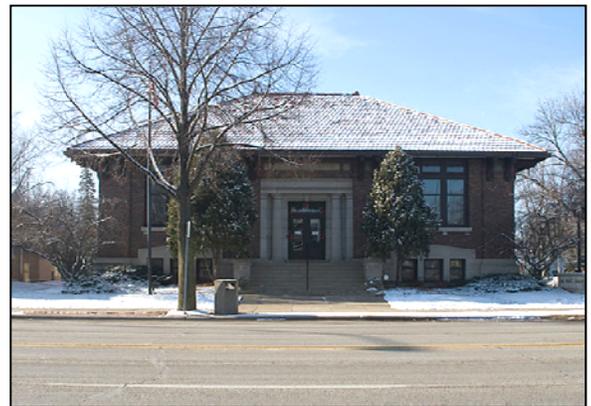
Photo ID: 001

The Ida Public Library was designed in the Prairie School style popular in the early 20th century. A strong horizontal orientation is suggested by the broad hip roof of clay tile, with the broad overhang and heavy brackets. The primary facade is symmetrically arranged, with central entry flanked by simple stone pilasters and heavy entablature that carries the building's name. On either side of the entry, a group of three tall windows, beneath which runs a bracketed stone sill, is centered in the dark brick wall. A wide flight of stone steps provides access to the double-doors of the main entrance, and the stone of the main stairs wraps around the building at the foundation. Beneath each window grouping on the main floor is a corresponding group of three smaller windows which provide views from the lower level. A surround of stone rises above the foundation to a shallow peak above each window grouping.

These treatments are repeated on the secondary facades. At the rear of the building, a 20th-century addition repeats the major design features of the original building: hip roof with broad overhang, windows in groups of three and the use of stone and concrete at the foundation level.

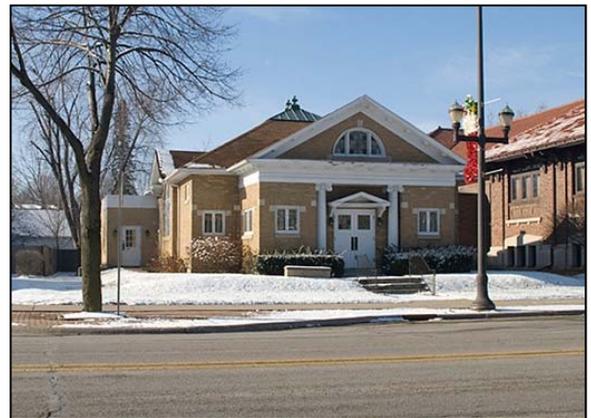
Photo ID: 002

Plan: Rectangular Stories: 1
 Roof Type: Hip
 Foundation:
 Walls: BRICK
 Sheathing:
 Windows: Double Hung, Casement
 Doors: WOOD, GLASS
 Trim: WOOD
 Roofing:
 Flashing:
 Chimney: BRICK

Class: Building Condition: Good Integrity: Medium

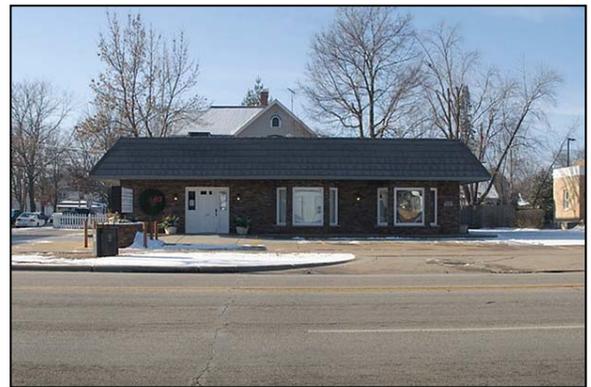
Photo ID: 003

Plan: Rectangular Stories: 1
 Roof Type: Flat
 Foundation:
 Walls: BRICK
 Sheathing: WOOD, BRICK
 Windows: Double Hung
 Doors: METAL, GLASS
 Trim: WOOD
 Roofing: ASPHALT SHINGLE
 Flashing:
 Chimney: BRICK

Class: Building Condition: Good Integrity: Low

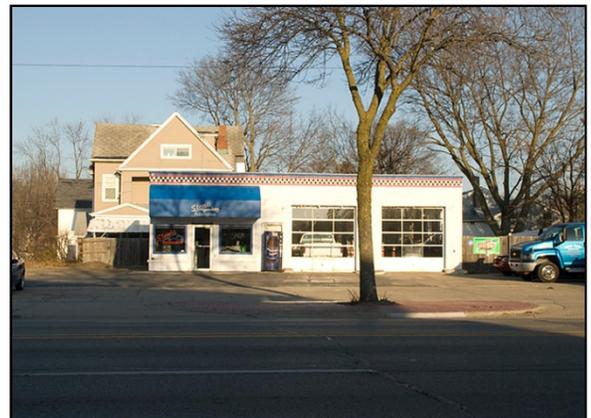
Photo ID: 004

Plan: Rectangular Stories: 1
Roof Type: Flat
Foundation:
Walls: CONCRETE
Sheathing:
Windows: Plate Glass
Doors: METAL, GLASS
Trim:
Roofing:
Flashing:
Chimney:

Class: Building Condition: Good Integrity: Medium

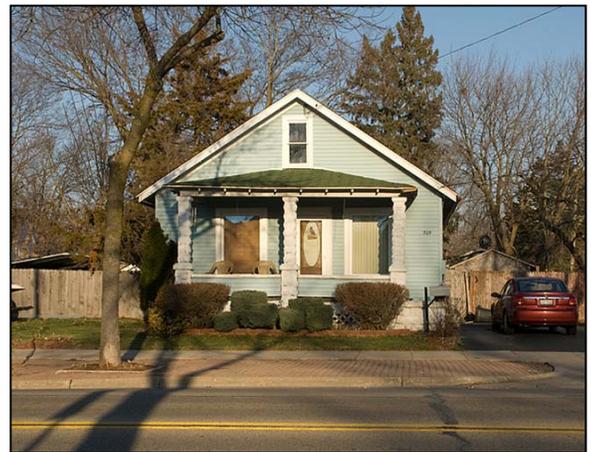
Photo ID: 005

This single-story frame dwelling has a foundation of concrete masonry units with a rusticated finish and presents a covered porch supported by piers of the same masonry units. The front entry is slightly off center, flanked by large plate glass windows. The structure has been sheathed in vinyl, and the windows all appear to have been replaced.

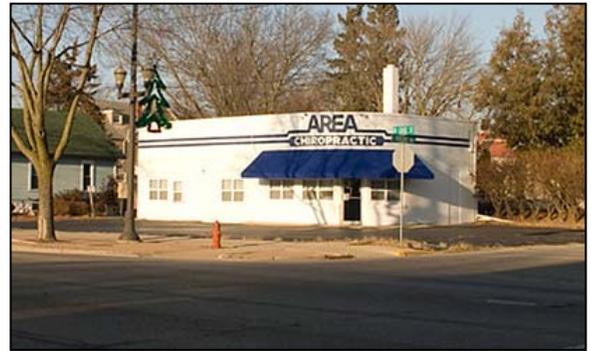
Photo ID: 006

Plan: Rectangular Stories: 2
Roof Type: Flat
Foundation:
Walls: CONCRETE
Sheathing: STUCCO, WOOD
Windows: Plate Glass
Doors: METAL, GLASS
Trim:
Roofing:
Flashing:
Chimney: CONCRETE

Class: Building Condition: Good Integrity: Medium

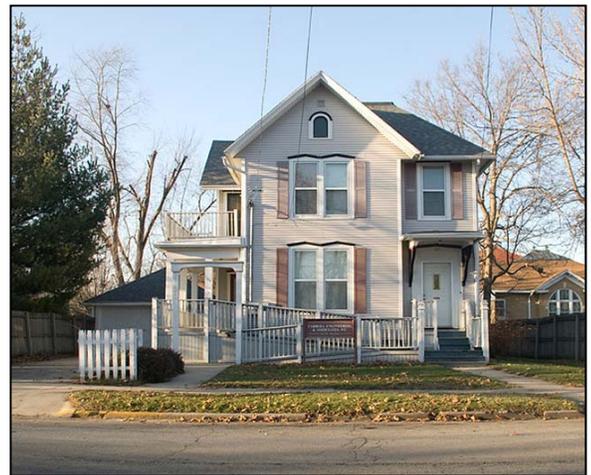
Photo ID: 007

Plan: Rectangular Stories: 2
Roof Type: Front Gable
Foundation:
Walls: WOOD
Sheathing: SYNTHETICS
Windows: Double Hung
Doors: WOOD, GLASS
Trim:
Roofing:
Flashing:
Chimney:

Class: Building Condition: Good Integrity: Medium

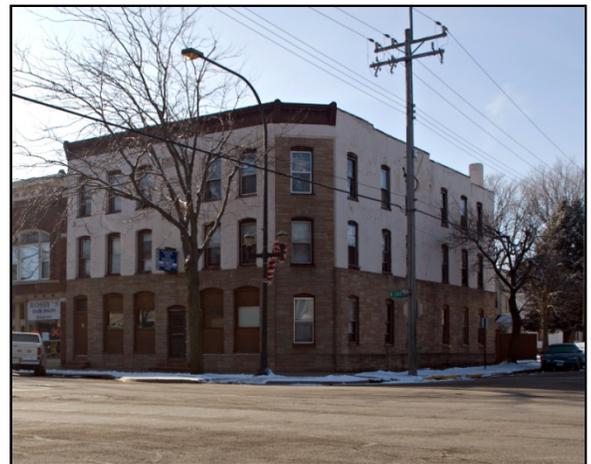
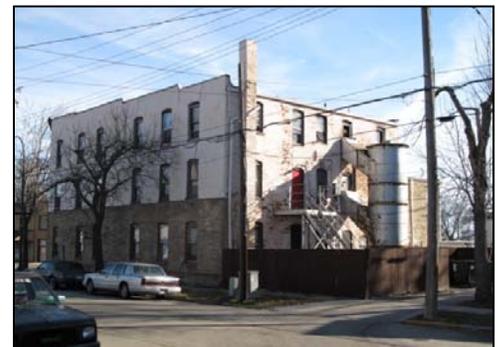
Photo ID: 008_1

This brick building was originally constructed as a boarding house and was later used for manufacturing before being used once more as a multiple dwelling. Although the first floor has been faced with multi-colored stone in a random ashlar pattern, the original penetrations appear to have been maintained. These include six openings facing State Street, six facing Hurlbut Street, and one centered in the diagonal wall facing the intersection. On the State Street façade, the first and fourth penetrations from the left are doorways and all others on the first floor are windows. Those facing State Street have been replaced with small plate glass windows and wood infill. The remaining penetrations present double-hung windows.

On the second and third floors, the walls are coated with a thin layer of stucco or parging and the placement of window openings is repeated from the first floor with one exception. On the State Street façade, the fourth bay from the left does not include a window penetration. The second floor of this bay presents a plain masonry wall, and on the third floor, panels of decorative brick—sawtooth courses of rowlocks and soldiers. At the corner of the building, the stone facing covers all three floors of the diagonal wall, surrounding a window penetration on each floor. On the Hurlbut façade, the arrangement of window penetrations on the first floor is repeated on the second and third floors. The building’s parapet is decorated with a wooden or metal cornice likely dating from the early 20th century. An enclosed fire escape is attached to the rear of the building.

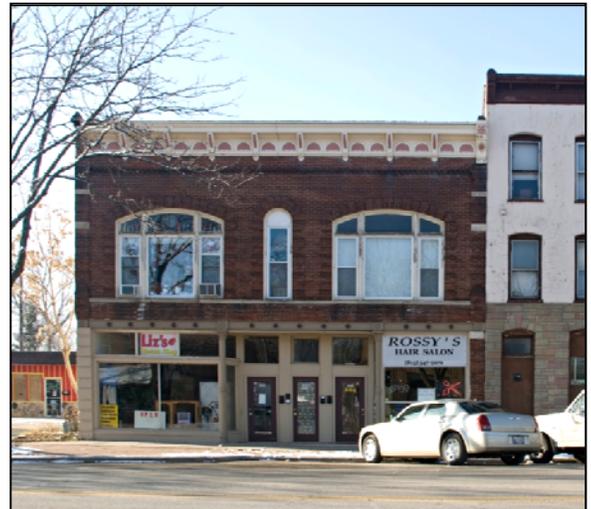
Photo ID: 009

Plan: Rectangular Stories: 2
Roof Type: Flat
Foundation:
Walls: BRICK
Sheathing:
Windows: Plate Glass, Double Hung
Doors: WOOD, GLASS
Trim:
Roofing:
Flashing:
Chimney:

Class: Building Condition: Good Integrity: Medium

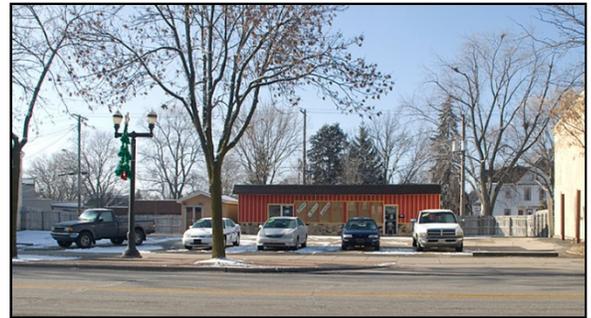
Photo ID: 010

Plan: Rectangular Stories: 1
Roof Type: Flat
Foundation:
Walls: WOOD
Sheathing:
Windows: Plate Glass
Doors: METAL, GLASS
Trim:
Roofing:
Flashing:
Chimney:

Historic Function: COMMERCE: business
Current Function: COMMERCE: business
References: Contemporary construction replaced the 1940's service station.

Class: Building Condition: Good Integrity: Medium

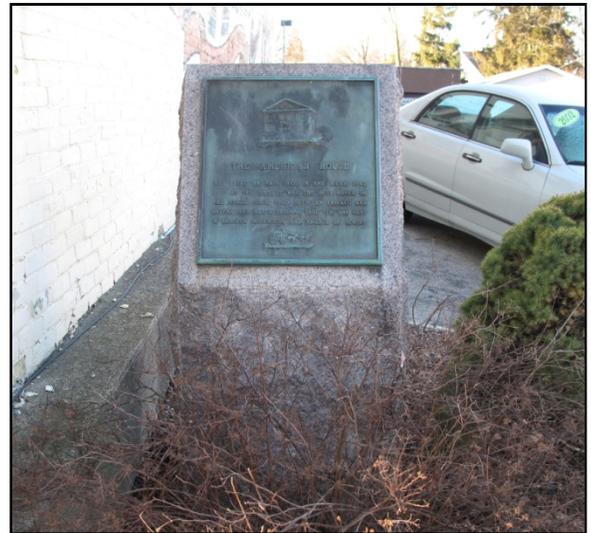
Photo ID: 011

Address: 212-1/2 (vicinity) North State Street	PIN:	Plan:	Stories:
Original Owner:		Roof Type:	
Building Names: American House Marker		Foundation: STONE	
Important Dates: ca 1950		Walls:	
Architect / Builder:		Sheathing:	
Architectural Style: Other: Other: See Comments		Windows:	
		Doors:	
Historic Function: RECREATION-CULTURE: monument/marker		Trim: METAL	
Current Function: RECREATION-CULTURE: monument/marker		Roofing:	
References: The marker is undated, but appears to have been erected in the mid-twentieth century.		Flashing:	
		Chimney:

Class: Object Condition: Excellent Integrity: High

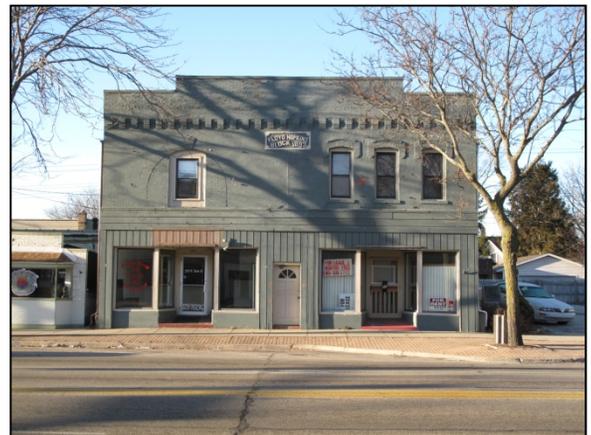
Photo ID: 012

Plan: Rectangular Stories: 2
 Roof Type: Flat
 Foundation:
 Walls: BRICK
 Sheathing: WOOD
 Windows: Double Hung
 Doors: WOOD, GLASS
 Trim:
 Roofing:
 Flashing:
 Chimney: BRICK

Class: Building Condition: Good Integrity: Medium

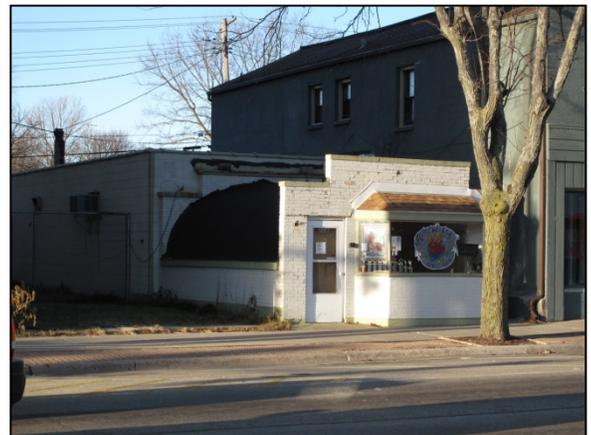
Photo ID: 013

Plan: Rectangular Stories: 1
Roof Type: Flat
Foundation:
Walls: BRICK, CONCRETE
Sheathing:
Windows: Plate Glass
Doors: WOOD
Trim:
Roofing:
Flashing:
Chimney:

Class: Building Condition: Good Integrity: Medium

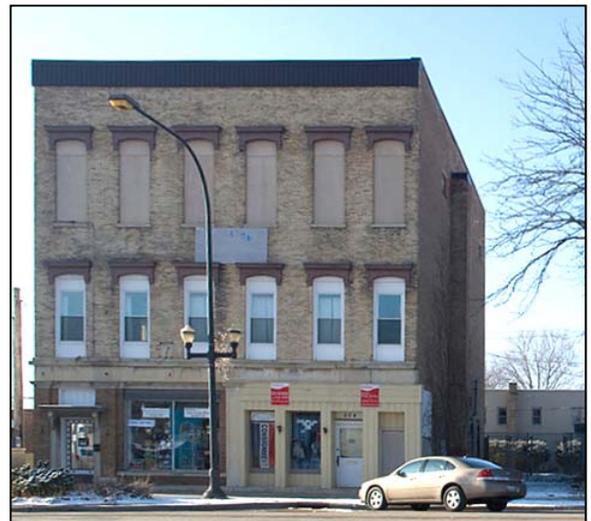
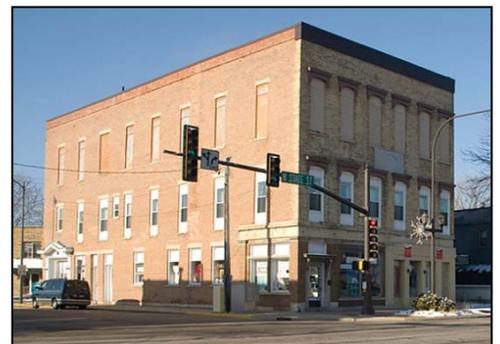
Photo ID: 014_1

This three-story brick building is featured on the 1858 and 1870 Boone County Farmers Maps as the home of the First National Bank and Brown & Co. Hardware. Although originally constructed as two buildings, the storefronts have a single cast iron header. The left-hand storefront presents brick piers supporting the header and a bracketed hood above the storefront entry. Large plate glass windows fill the remainder of this storefront. The remaining storefront is sheathed in wood, obscuring the materials beneath, and is divided into four recessed bays. The first two present narrow plate glass windows; the third, the storefront entry; and the last, access to the stairs to the upper floors. Above the storefronts on the second floor is a series of six window penetrations topped by stone hoods incorporating segmental arches, and this fenestration is repeated on the third floor. A cornice of dark brown material stretches across the parapet at the top of the building. The secondary façade presents a contemporary hooded entrance at the far left with a series of window and door penetrations across the façade. The second and third floors present regularly spaced windows with narrow rusticated stone sills and lintels.

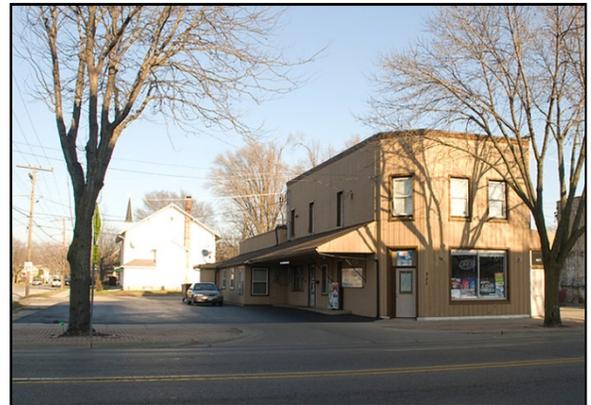
Photo ID: 015

Plan: Rectangular Stories: 2
 Roof Type: Flat
 Foundation:
 Walls: BRICK
 Sheathing: WOOD
 Windows: Double Hung
 Doors: METAL, GLASS
 Trim: TILE
 Roofing:
 Flashing:
 Chimney:

Class: Building Condition: Good Integrity: Medium

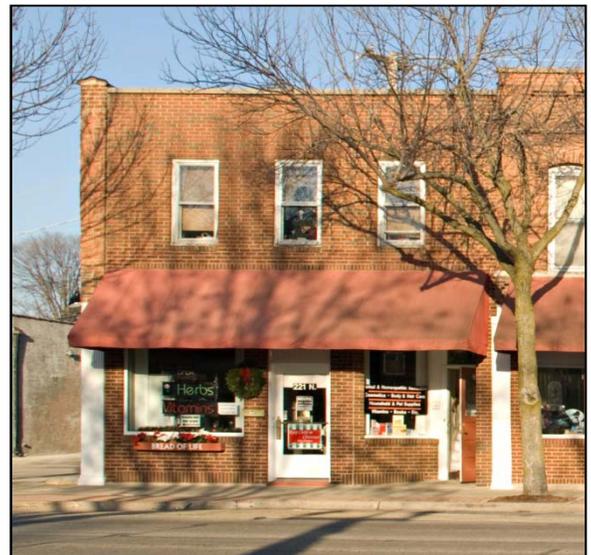
Photo ID: 016

Plan: Rectangular Stories: 2
Roof Type: Flat
Foundation:
Walls: BRICK
Sheathing:
Windows: Double Hung
Doors: WOOD, GLASS
Trim:
Roofing:
Flashing:
Chimney: BRICK

Class: Building Condition: Good Integrity: Medium

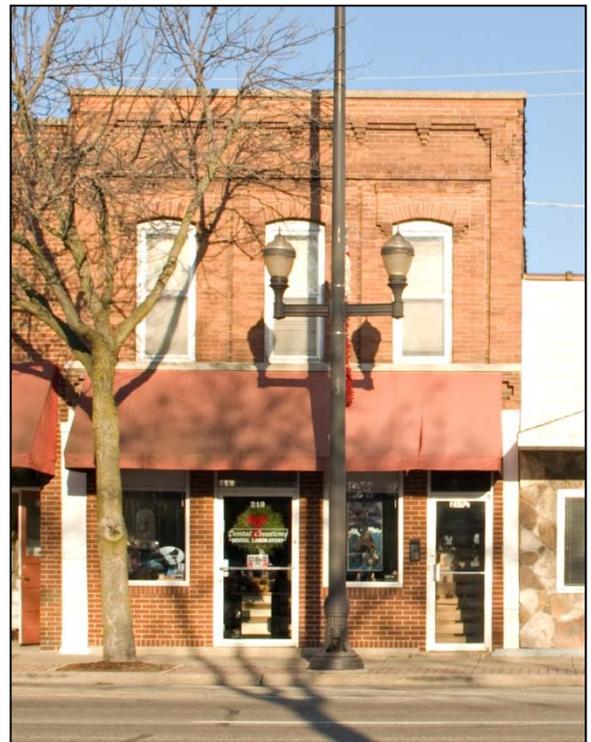
Photo ID: 016

Plan: Rectangular Stories: 1
Roof Type: Flat
Foundation:
Walls: BRICK
Sheathing: METAL,
Windows: Casement
Doors: METAL
Trim:
Roofing:
Flashing:
Chimney:

Class: Building Condition: Good Integrity: Low

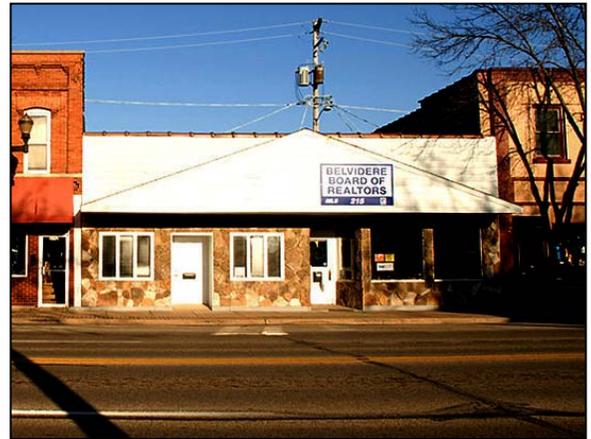
Photo ID: 018

The storefronts of this single-story commercial structure has been faced with rustic stone. The storefront on the left has a central entry flanked by groups of three casement windows. The other storefront has a recessed entrance on the left, with two plate glass windows to the right of the door. Above both storefronts, a pediment sheathed with wood siding projects slightly from the original brick façade, which has been painted white and is finished with tile coping.

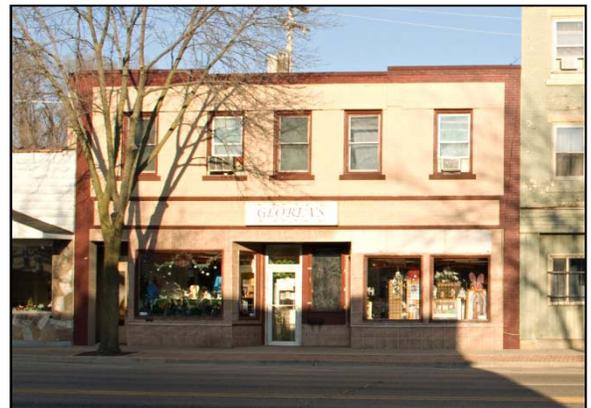
Photo ID: 019

The recessed entry for the storefront of this two-story brick commercial building is roughly centered on the façade, flanked by plate glass windows. To the far left is an entry leading to the second floor. The storefront is faced in stone tile, which has delaminated above the right-hand storefront windows, revealing a cement-like base. Original window penetrations have been maintained on the second floor though it is unclear whether the windows have been replaced. The five windows at this level are grouped, with a set of three a bit more closely spaced in the center of the façade, with a single window flanking the group on either side. The line of the parapet is unusual, as it stair-steps down slightly in the middle, rather than rising which is more common for buildings of this period. Plain coping finishes the parapet. The area surrounding the windows and the brick panel above the storefront have been painted.

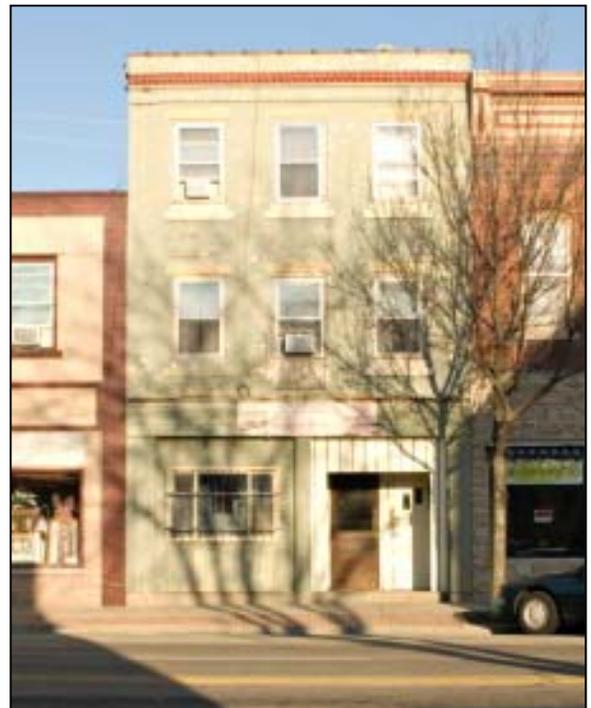
Photo ID: 019

The second and third floors each present three double-hung windows spaced evenly across the façade. Stone sills and lintels have been retained, though the windows appear to have been replaced, the penetrations filled at the bottom to accommodate shorter contemporary windows. A simple cornice is composed of two projecting courses of brick topped by two corbelled courses of sawtooth rowlocks, above which a few plain courses of brick are capped by tile coping.

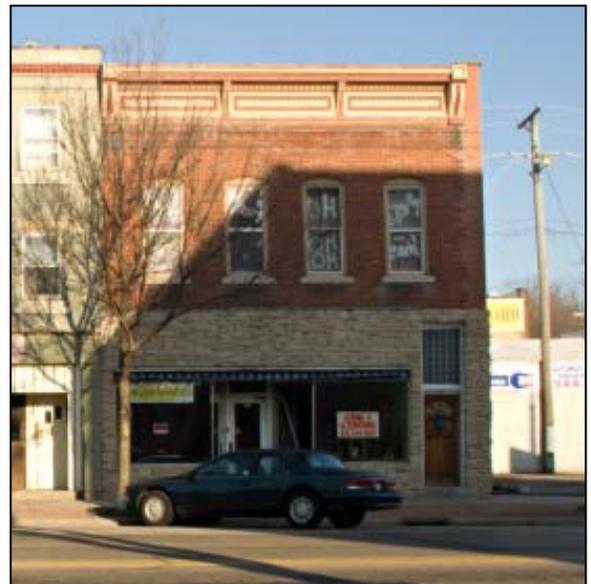
Photo ID: 019

Plan: Rectangular Stories: 2
Roof Type: Flat
Foundation:
Walls: BRICK
Sheathing: WOOD
Windows: Double Hung
Doors: WOOD, GLASS
Trim: METAL
Roofing:
Flashing:
Chimney:

Class: Building Condition: Good Integrity: Medium

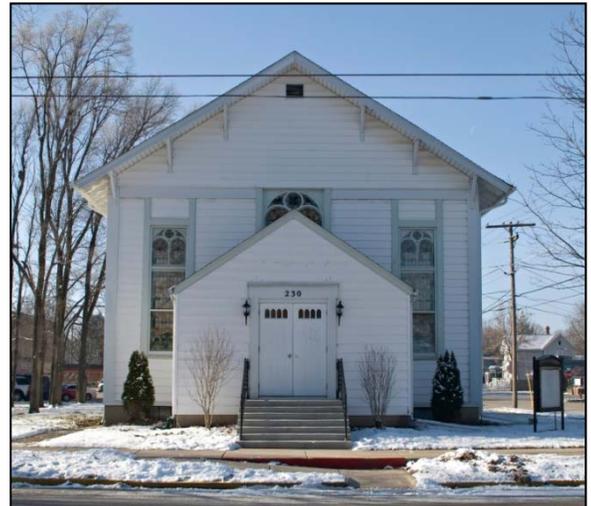
Photo ID: 023

This simple front-gabled frame church is sheathed in wooden clapboards and trimmed with simple planks. Rectangular window penetrations defined by those planks, painted gray, present windows of stained and leaded glass with Roman arches. The bracketed roof and the trim are common to the Craftsman Style, which was popular in the early 20th century. The entry vestibule projects from the front of the building and lacks the decorative features of the rest of the building, suggesting that it had undergone remodeling since its construction ca 1920.

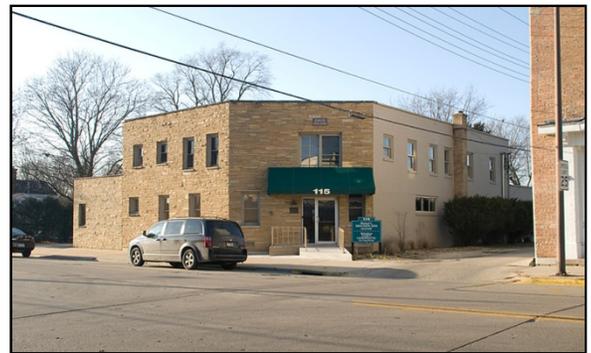
Photo ID: 024

Constructed as a clinic in 1950, this two-story structure of concrete masonry units (CMUs) is faced with rusticated fieldstone in rectangular units of varying height. Random stones project slightly from the façade. The footprint of the original structure was polygonal: a rectangle with one corner removed, the entrance situated off-center in the angled façade. A double-hung window is situated at either end of that façade. A pair of what appear to be French doors above the main entrance are partially obscured by a fabric awning which is centered over the entryway. A plaque with the inscription "Davis Building" is centered above the French doors.

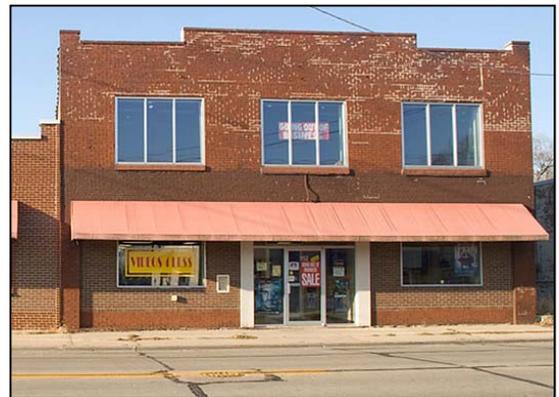
Photo ID: 025

This two-story commercial building mimics the basic design of its neighbor at 110 East Lincoln. The building presents a central entrance flanked by a plate glass window on either side. Storefront windows appear to have been recently replaced with smaller windows and filled with brick and mortar that is lighter than the original. A fabric awning stretched across the main façade. On the second floor, three evenly-spaced windows penetrations have been filled with contemporary casement windows. Rising above the three penetrations is a plain brick parapet wall. The center third of the parapet rises four courses higher than the wall on either side, as does a short segment of the wall at the corners of the building. Plain light-colored coping caps the parapet wall.

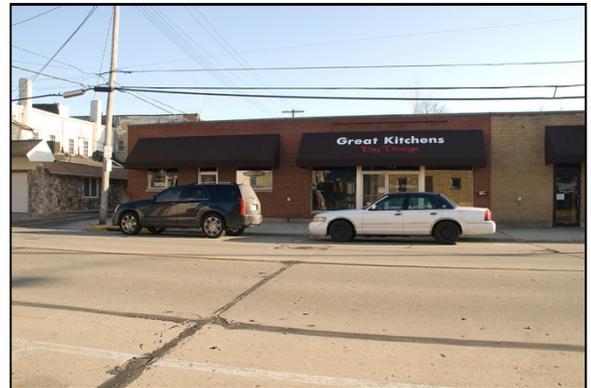
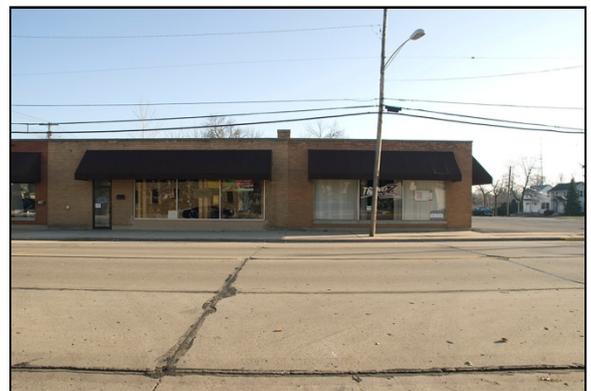
Photo ID: 028_1

This simple single-story brick commercial building presents four storefronts: from the left, the first two are faced with dark brown brick. The first presents a central entry of metal and glass, flanked by two small windows. The second presents a storefront almost completely of glass divided roughly in three. The center section consists of a door and window framed in light-colored metal. The next storefront is faced in a light brown brick. One penetration presents a door on the left side of the façade. To the right is a single wide penetration filled with three plate-glass windows. It appears that the penetrations once reached all the way to the sidewalk; these have been partially filled with brick about ten courses high. The final storefront facing Lincoln Street is actually the secondary façade for a shop that faces west into the adjacent parking lot. The Lincoln Street façade presents a single penetration filled with three large plate glass windows, while the short main façade facing the parking lot presents an entrance and a single plate glass window. Each storefront is visually indicated by a simple fabric awning that shades all the window and door penetrations on each storefront.

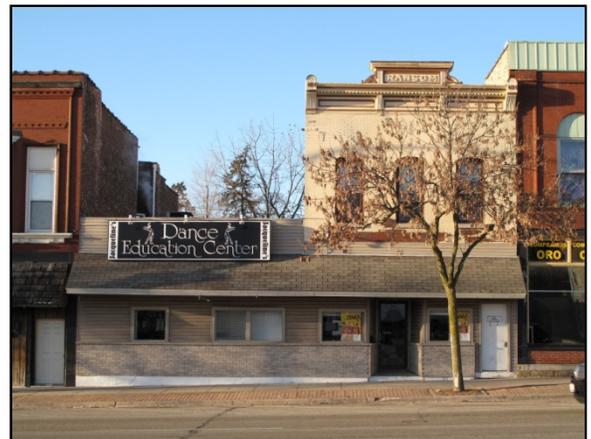
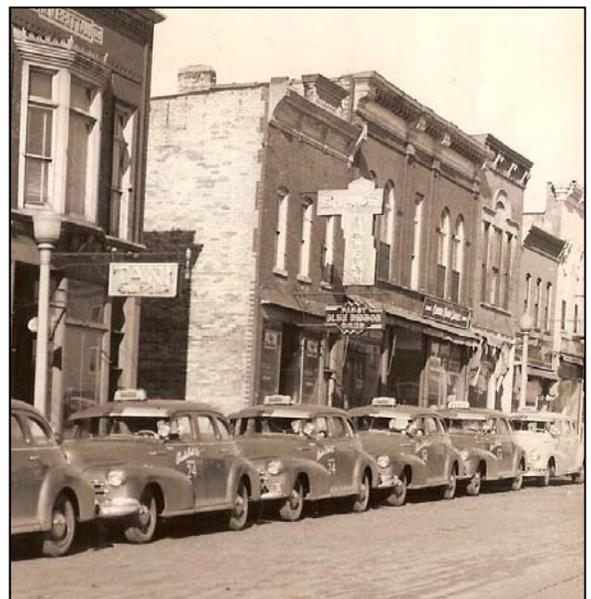
Photo ID: 035

The storefront of this two-story brick building has been replaced with contemporary materials: light-colored brick wainscoting provides a sill upon which a pair of plate glass windows rest. These flank a recessed entrance, which is slightly left of center. A second entry to the second floor is positioned at the far right hand side of the building. Vinyl siding sheathes the walls, and a wooden awning with asphalt shingles stretches over the storefront. This treatment of the first floor extends to the adjacent building, number 122.

The building's second floor presents three double-hung windows with segmental arches evenly spaced across the façade. Above these a flat expanse of brick extends up to the bracketed cornice of pressed metal, which includes the building's name. The cornice and brick have been painted.

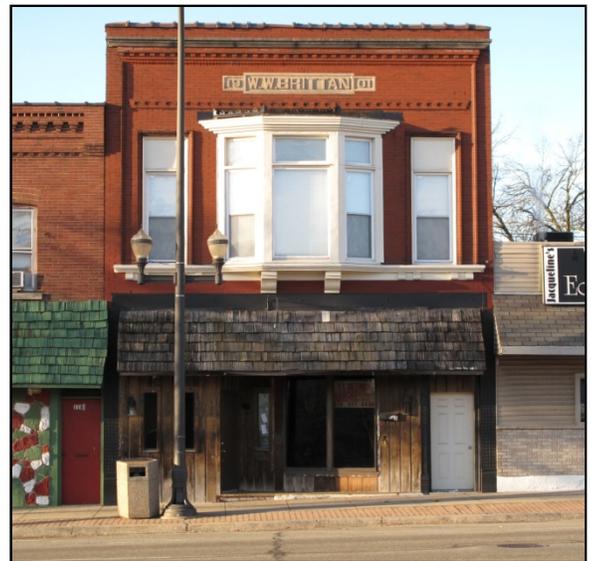
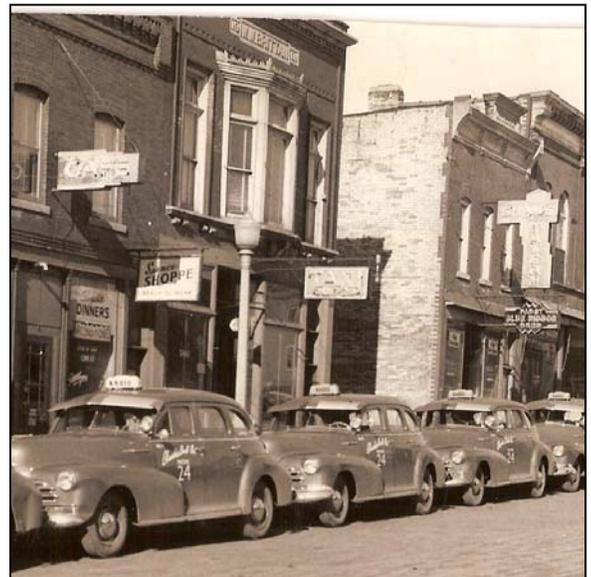
Photo ID: 037

The storefront of this building has been filled with vertical wooden siding. Access to the second floor is provided by a steel door at the right end of the main façade. A recessed storefront entrance is positioned in an angled wall on the left. Plate glass windows of varying sizes pierce the wooden walls, and a fixed awning sheathed with wooden shingles stretches across the storefront. The second floor presents a symmetrical arrangement of windows resting on a bracketed sill. In the center is an oriel window composed of a plate glass window flanked by double-hung windows. Two large brackets appear to support this window, while smaller brackets are positioned beneath the sills of two more double-hung windows that flank the oriel window. These appear to be contemporary replacement windows. Above these windows is a plaque with the building's name, above which corbelled brick supports a projecting stone cornice. Clay coping tiles top the parapet wall.

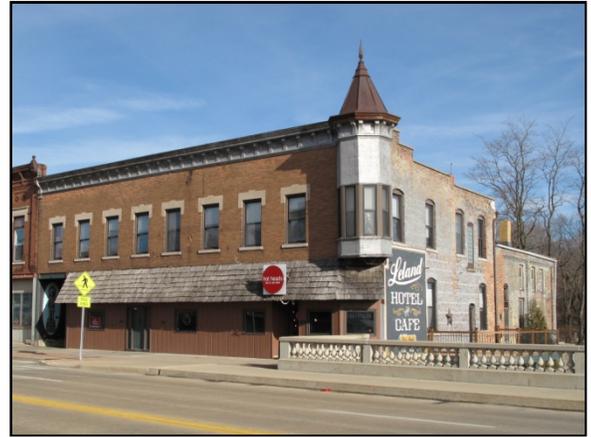
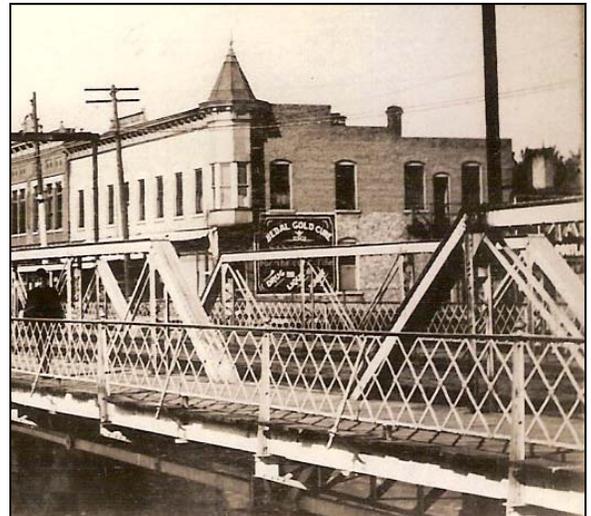
Photo ID: 049

The storefront of this nine-bay building has been replaced with contemporary materials. Two entries and four small plate glass windows penetrate a wall of vertical wooden siding that stretches across eight of the nine bays. This section of the storefront presents a fixed awning of wood sheathed with wooden shingles. The last bay on the left provides access for automobiles to the rear of the building. The second floor façade presents a single double-hung window in eight of the nine bays. Each of these has a heavy dressed stone lintel and narrow stone sill. At this level, the last bay on the right is treated differently, here the location of a projecting octagonal tower. At the top of the parapet, a bracketed pressed metal cornice runs the length of the building and wraps around the tower, which has a conical roof with finial which appear to date to the building's original construction.
