Belvidere Historic Resources Inventory: Commercial Historic District

Section B

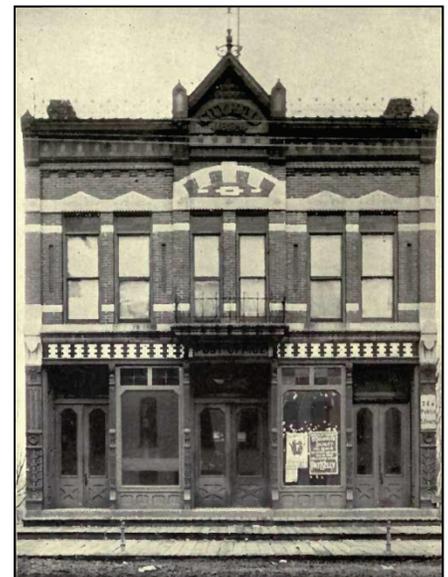
Photo ID: Belvidere_015

This façade of this two-story building of red brick building is divided cleanly in two. On the left, five bays on the first floor are marked by heavy brick pilasters which appear to support a simple projecting cornice of stone. The penetrations in the first floor bays have been partially filled with glass block and masonry except for the far right bay, which presents a metal and glass entry. The second floor presents three bays. The central bay is the same width as the one below it and presents a pair of narrow window penetrations, the one on the left filled with masonry. The central bay is flanked by two wider bays presenting two window penetrations each. Replacement windows shorter than the originals have been installed in two of these openings, and the others have been filled with masonry. Above the central bay is a cast stone plaque noting this portion of the building's construction date, 1884.

The right half of the building is of the same size and massing, except that the first floor bays have been reduced in number to three. The far left bay includes a contemporary metal and glass entrance, and the other two bays, of varying size, each present an overhead door providing access to the Fire Department's apparatus bays. The arrangement and treatment of window bays and penetrations on this side of the building are identical to those on the left; a cast stone plaque noting the construction date of the building addition, 1917, is centered above this section of the building.
